DEPARTMENT OF TRANSPORTATION**DIVISION OF ENGINEERING SERVICES**

Quality Assurance and Source Inspection

Contract #: 04-0120F4Cty: SF/ALA Rte: 80 PM: 13.2/13.9File #: 69.28**WELDING INSPECTION REPORT****Resident Engineer:**Siegenthaler, Peter**Address:** 333 Burma Road**City:** Oakland, CA 94607**Report No:** WIR-022480**Date Inspected:** 08-Apr-2011**Project Name:** SAS Superstructure**OSM Arrival Time:** 700**Prime Contractor:** American Bridge/Fluor Enterprises, a JV**OSM Departure Time:** 1900**Contractor:** Zhenhua Port Machinery Company, Ltd (ZPMC), Changxing Island **Location:** Shanghai, China**CWI Name:** An Qing Xiang**CWI Present:** Yes No**Inspected CWI report:** Yes No N/A**Rod Oven in Use:** Yes No N/A**Electrode to specification:** Yes No N/A**Weld Procedures Followed:** Yes No N/A**Qualified Welders:** Yes No N/A**Verified Joint Fit-up:** Yes No N/A**Approved Drawings:** Yes No N/A**Approved WPS:** Yes No N/A**Delayed / Cancelled:** Yes No N/A**Bridge No:** 34-0006**Component:** OBG**Summary of Items Observed:**

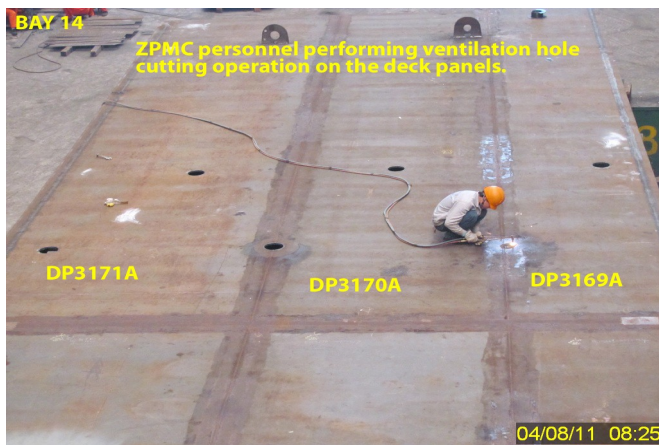
During random in process visual inspection this QA Inspector observed that ZPMC personnel was performing ventilation hole cutting operation on deck panels DP3169A/DP3170A/DP3171A. Attached photograph provide additional details.
